Addison, Texas, July 1, 2008 - MSF Partners, Inc. has begun construction of an executive hangar community at Addison Airport today. This complex is being developed as a condominium association and named the Executive Hangars of Addison Association. Twenty three units in three sizes ranging up to over 8,000 square feet are being built. Richard French, MSF Partner's President, commented on the executive hangars, "We are excited to see dirt moving on what will be the most beautiful hangar community at the airport. Our buyers and their guests will enjoy amenities far beyond those to be found at the airport today. The high-end exterior and interior finish will set these units apart from any to be seen there today". Completion is planned for May 2009. MSF Partners, Inc. is located in Plano, Texas a northern suburb of Dallas. For further information, contact MSF Partners at 6900 N. Dallas Parkway, Suite 730, Plano, Texas 75024; call (972) 403.0909; or log on to www.msfpartners.com. --- MSF Partners ---

MSF Partners/IAM Construction contracted with REDFORD Corporation to paint the structural steel and install a high performance epoxy/urethane coating system [twenty three (23) hangars]. Th

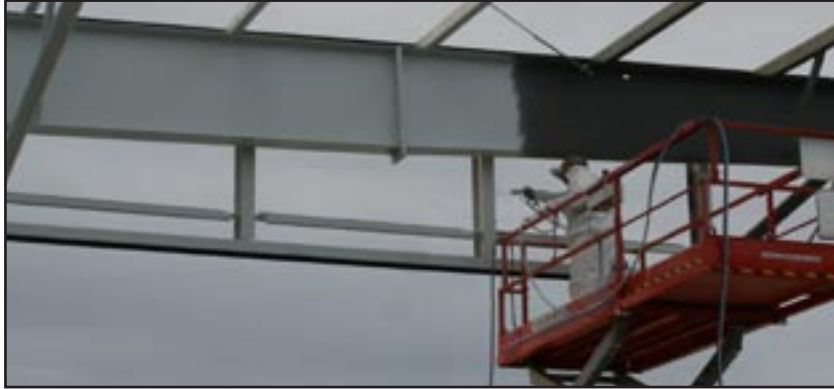
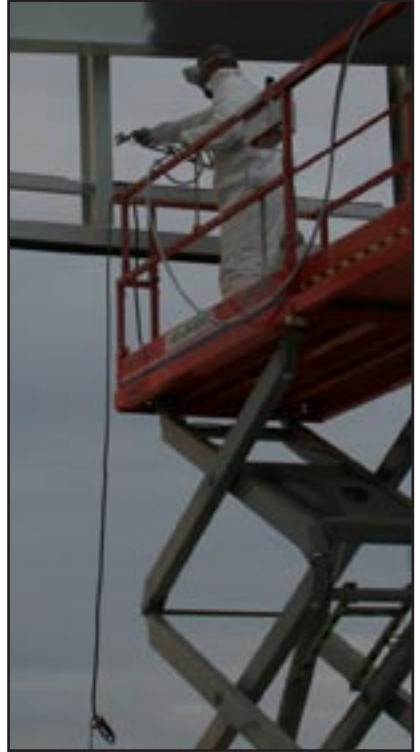
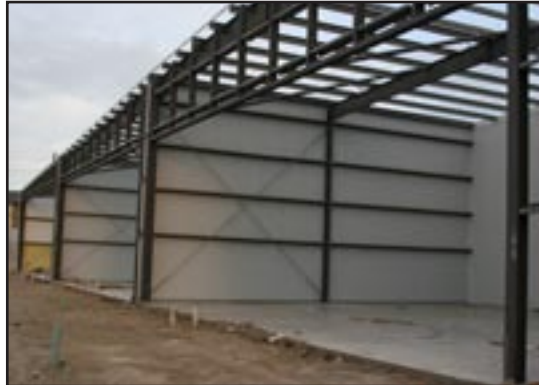
Additional photographs of the structural steel.

These photographs show a DTM acrylic being applied to the structural steel (March 2009).

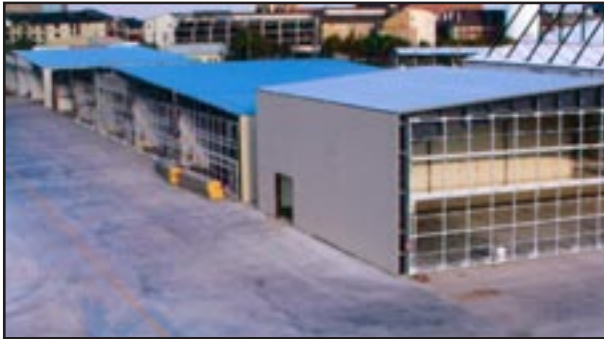
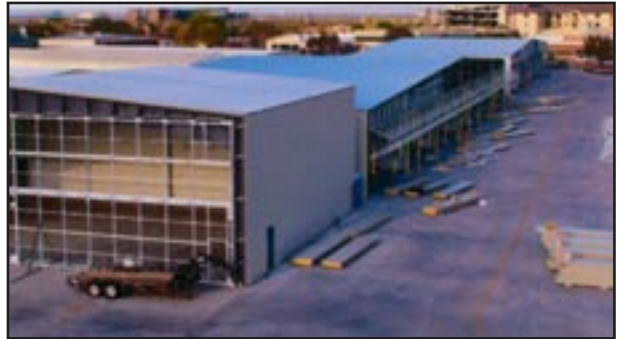
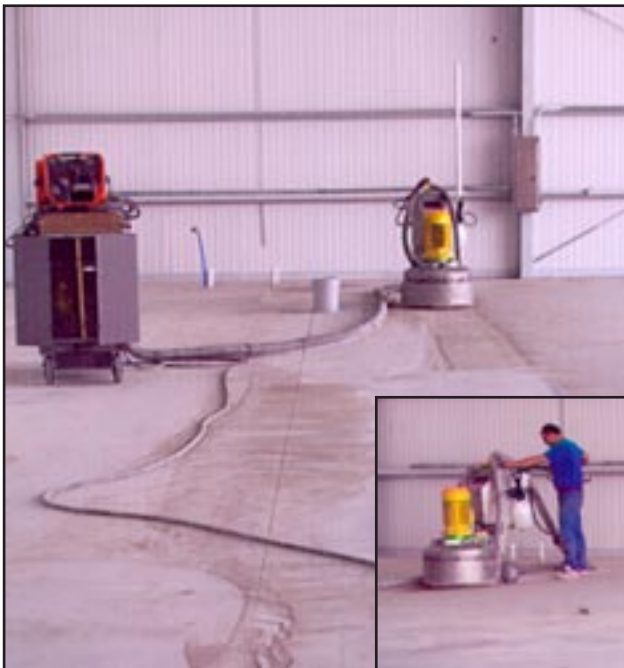
The north and south side including the front of the 23 hangars being constructed. Photographs taken on March 18, 2009 with completion planned for May 2009.

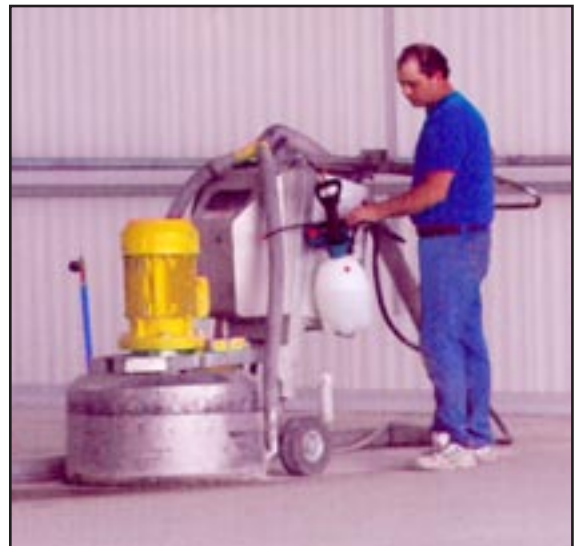
The start of the shot blasting / diamond grinding of the 23 hangars.

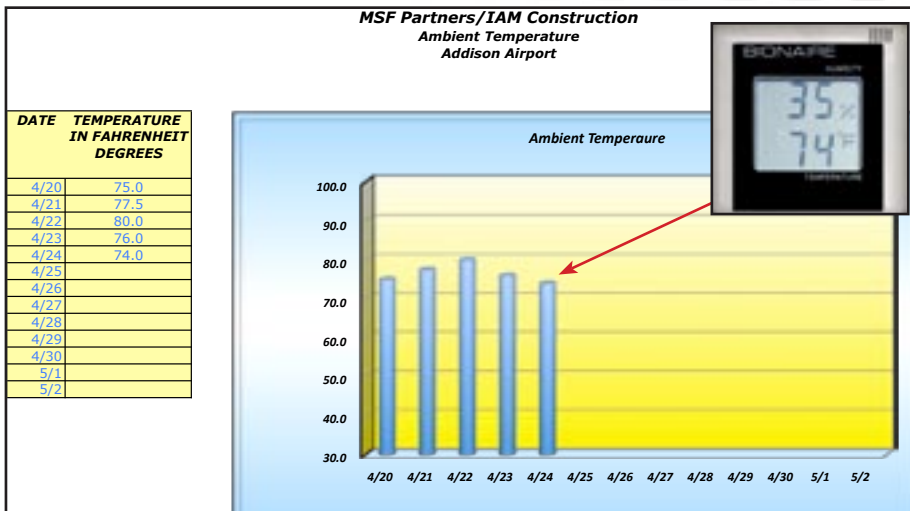
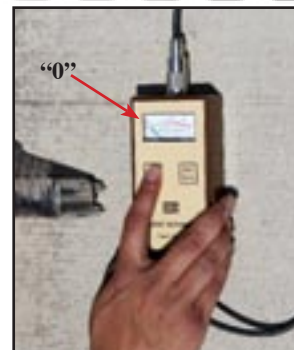
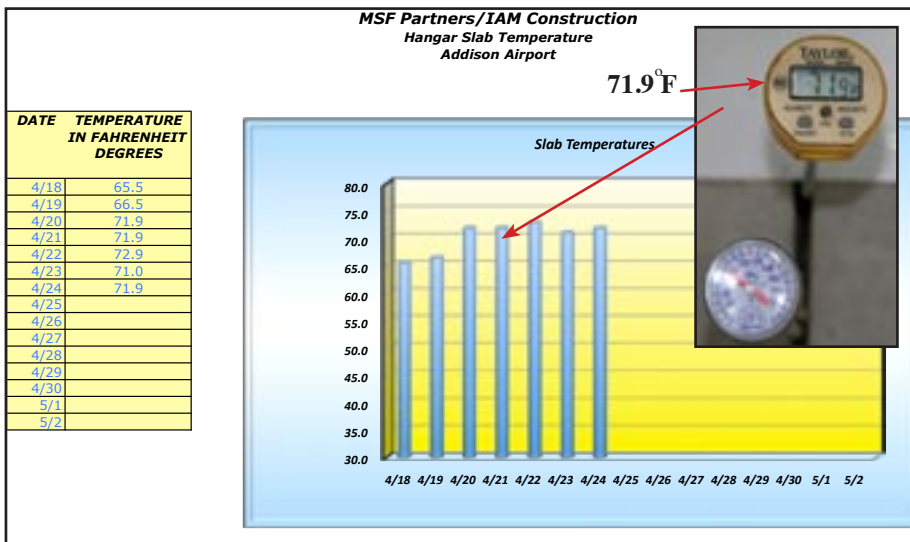
Delmhorst Instrument Company - - these photographs show a meter testing electrical conductivity of the moisture present in the Addison hangar floors. The meter then extrapolates readings on a relative basis. It does not give actual moisture content. The idea is to get readings that continually go down. Generally, we plot these on a graph and apply coatings when we see a bottom and are "comfortable". We also plan to run calcium chloride tests (from Vaprecision, Inc.).

The top two photographs show the drainage ditch outside the hangars (the "control"). The ditch shows "0" because of the sun/heat, compared to "pegging" the meter inside the hangars (because of cold temperatures, moisture in the concrete, and relative humidity).

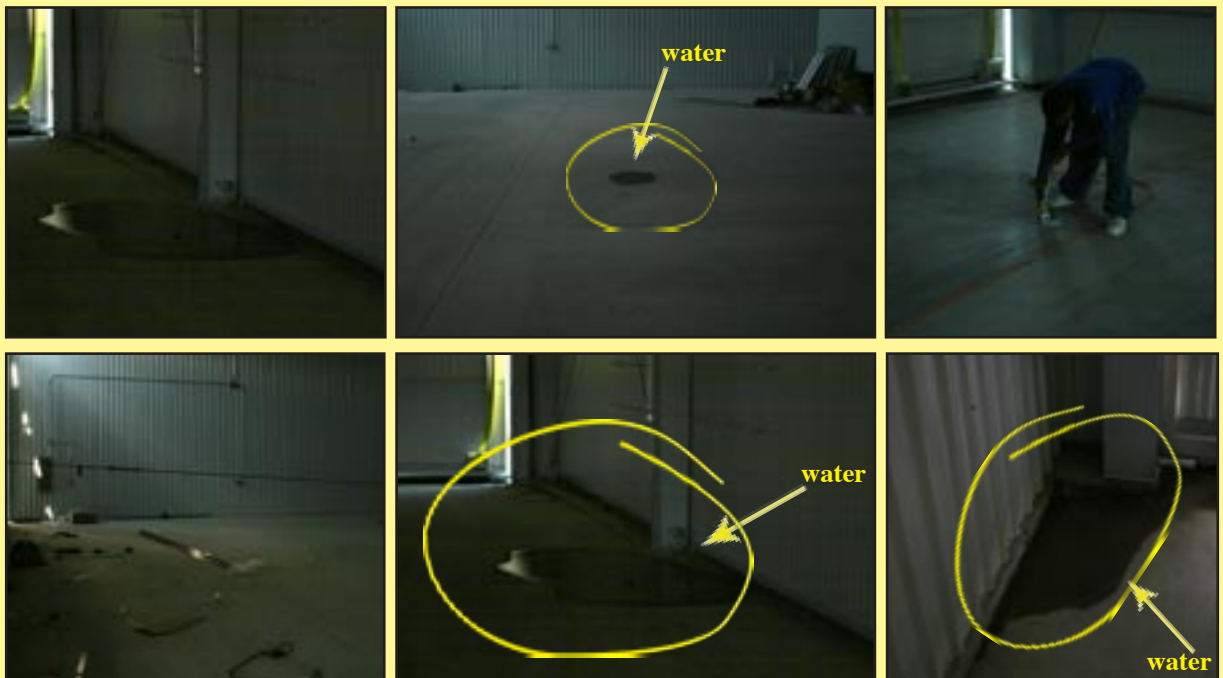
All of this is presented to explain that the highly cross-linked, dense urethane topcoats cannot “breathe”. Any residual moisture in the concrete capillaries will be “pushed up” / expanded when the concrete temperature increases (moisture manifesting itself as bubbles), or in other words, **hydrostatic pressure**.

Photographs showing actual conditions (April 24, 2009).
