Memorandum

To: Richard French
 From: Keith Redford
 Date: November, 2008
 Subject: **MSF Partners** (Hangar Floor Problem), McKinney, Texas

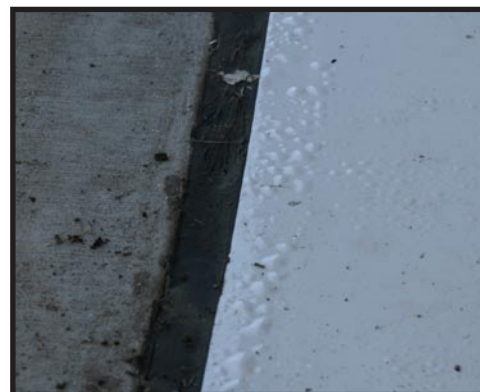
Unfortunately, the highly cross-linked urethane topcoat (and **because of the good topcoat properties**, i.e., good color development, long-term gloss, abrasion resistance, chemical resistance, etc.) bubbled (because the urethane topcoat cannot breathe). This bubbling occurred

FIGURE 1: Photographs showing bubbles

because of osmosis of trapped water (exaggerated by the proximity of a one (1”) inch cold joint). Again, the osmosis (passage of water) through the semi-permeable pores of the concrete is “bubbling” the front of the hangars, but limited to approximately twelve (12”) inches (see Figure 1) inside the hangar floor from the apron.

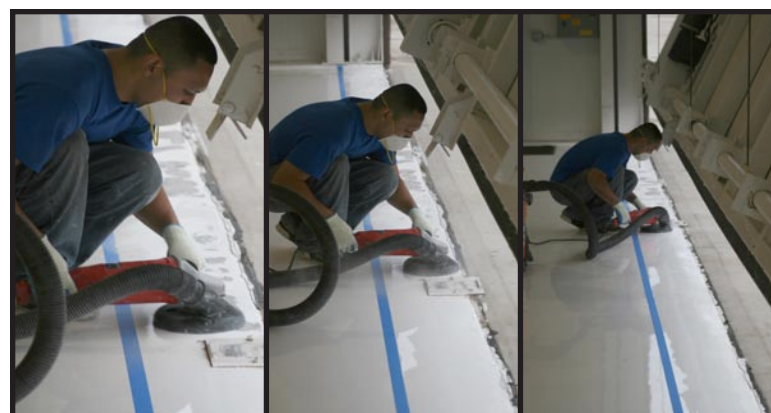
FIGURE 2-4: Diamond grinding / removing bubbles to bare concrete

In October 2008, **MSF Partners** asked us to help solve the problem [(pronounced, but limited to seven (7) hangars of twenty-four (24)]. We started by diamond grinding the bubbled areas to bare concrete (see Figure 2-4) followed by burning the removed areas (see Figure 5). Then, following the suggestions of many, **MSF Partners** removed three (3) of the front hangar cold joints (filled with a bituminous tar-like mixture of hydrocarbons derived from petroleum (see Figure 6). This was removed to eliminate standing/trapped

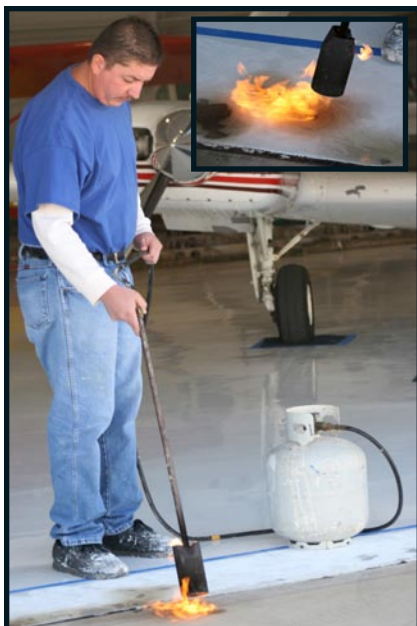
FIGURE 5: Flame treating surface removing moisture

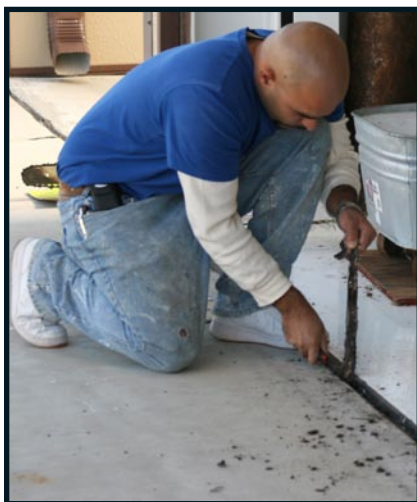
FIGURE 6: Removing bituminous tar-like caulk

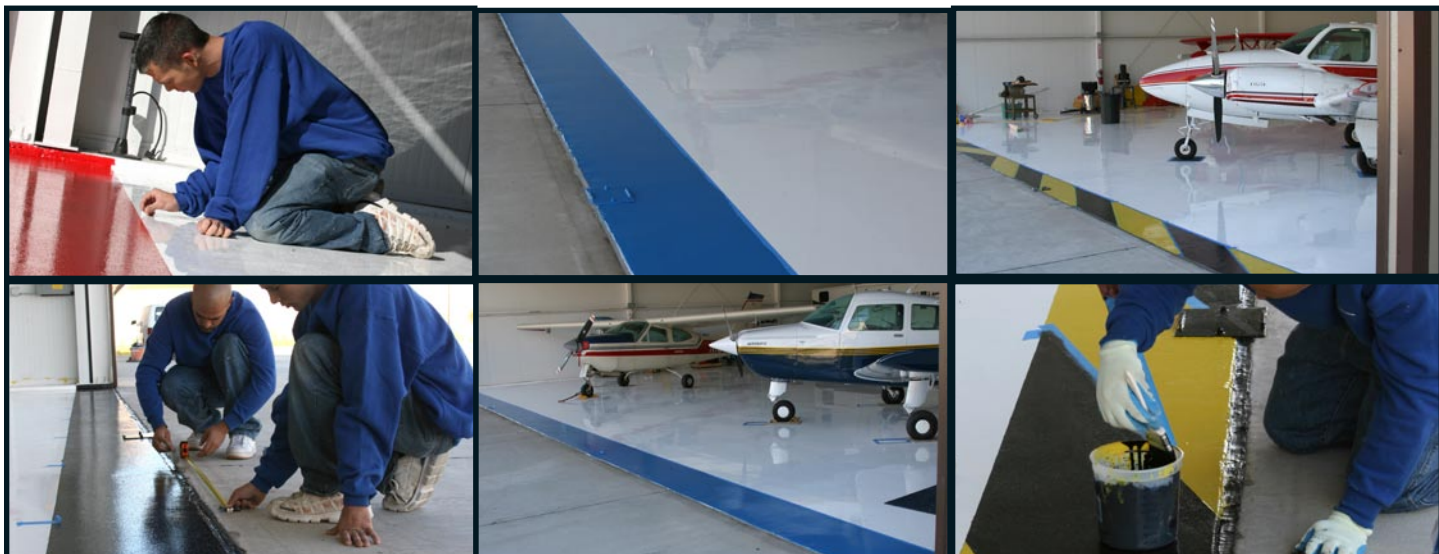
FIGURE 8-13: Hangar "lip" repaired/test areas installed.

water. This was followed by caulking with **E31-1205** after surface preparation and placing of backer rod. We then "re-prepared" the removed surface and primed with **E31-1202**; then top-coated with **U31-1201** (see Figure 8-13) high performance urethane.

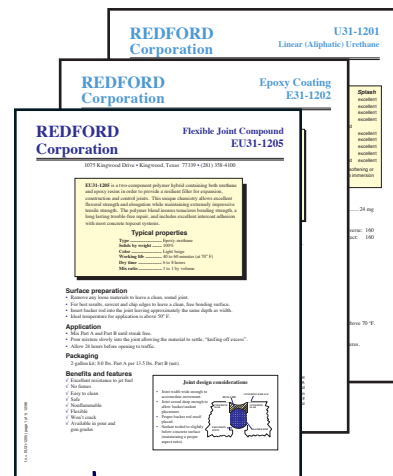
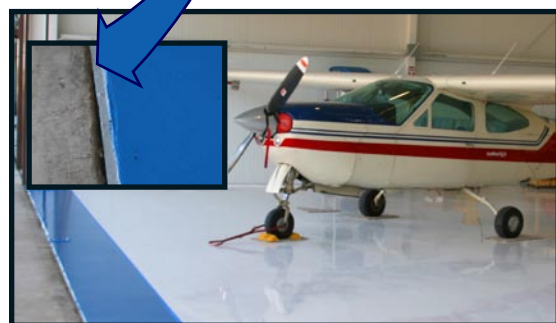
FIGURE 7: Caulking with E31-1205
