Aircraft service center located at Fulton county Airport, Georgia (approximately 27,000 square feet coated in 1980). Floor was in "bad" shape and "showed" almost 23 years of use.

1st phase completed March 2004; 2nd phase planned for April 2004

CORPORATE HANGAR RAYTHEON AIRCRAFT SERVICES

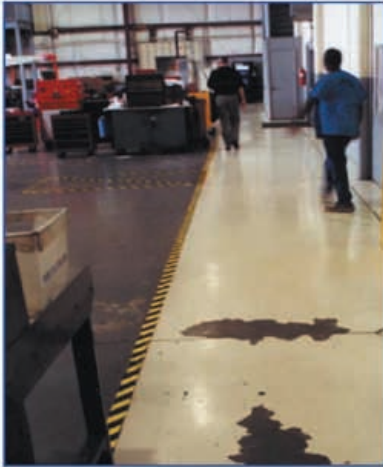
Hangar conditions at project start

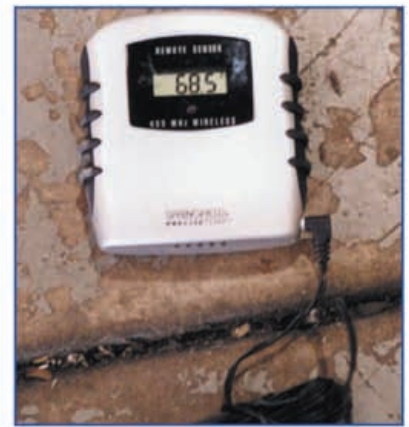
Temperature of concrete floor at project start

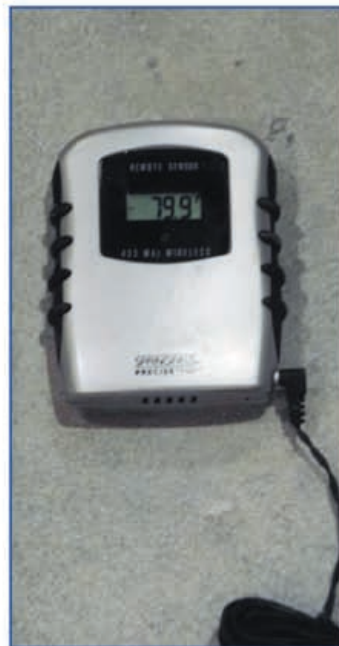
Temperature of floor at Primer start
