Business Jet Center
8611 Lemmon Avenue
Dallas, Texas 75209

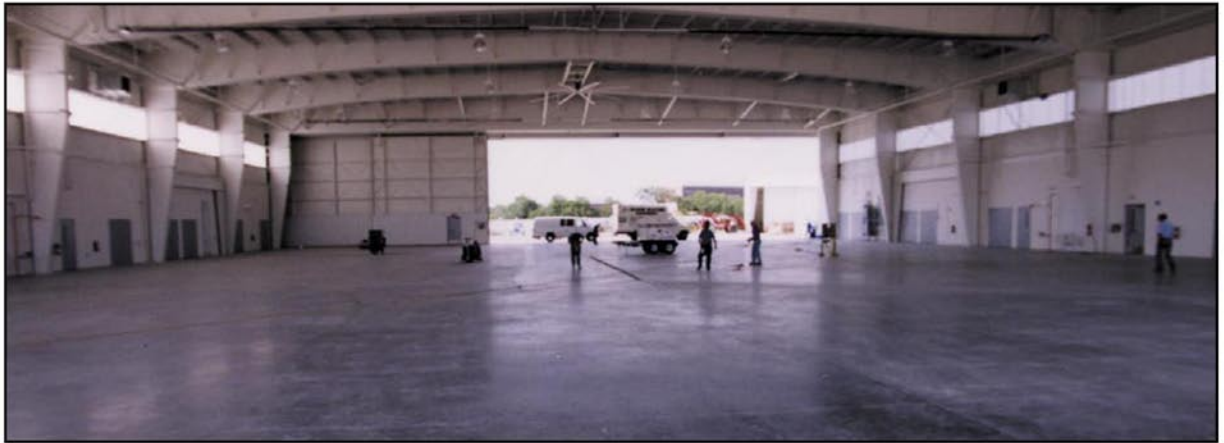
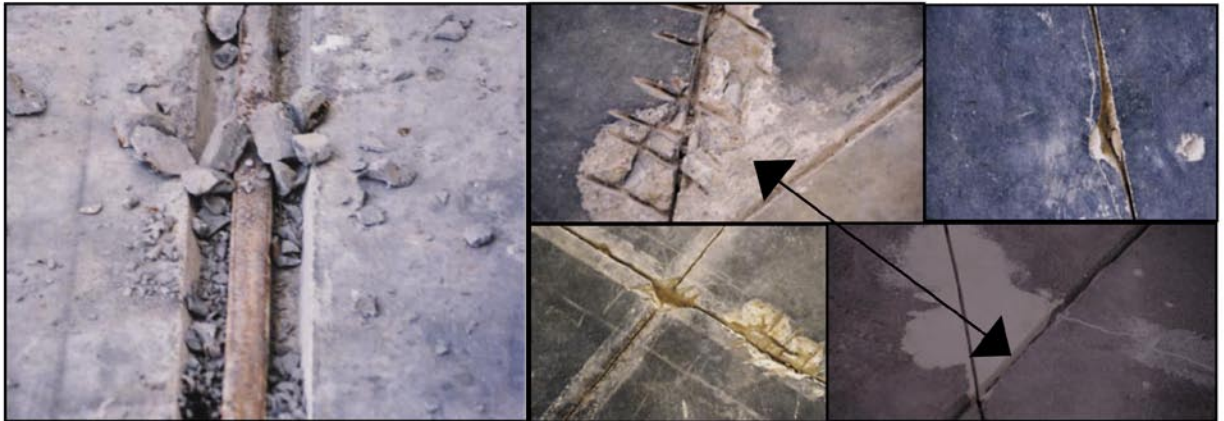
Hangar conditions at project start

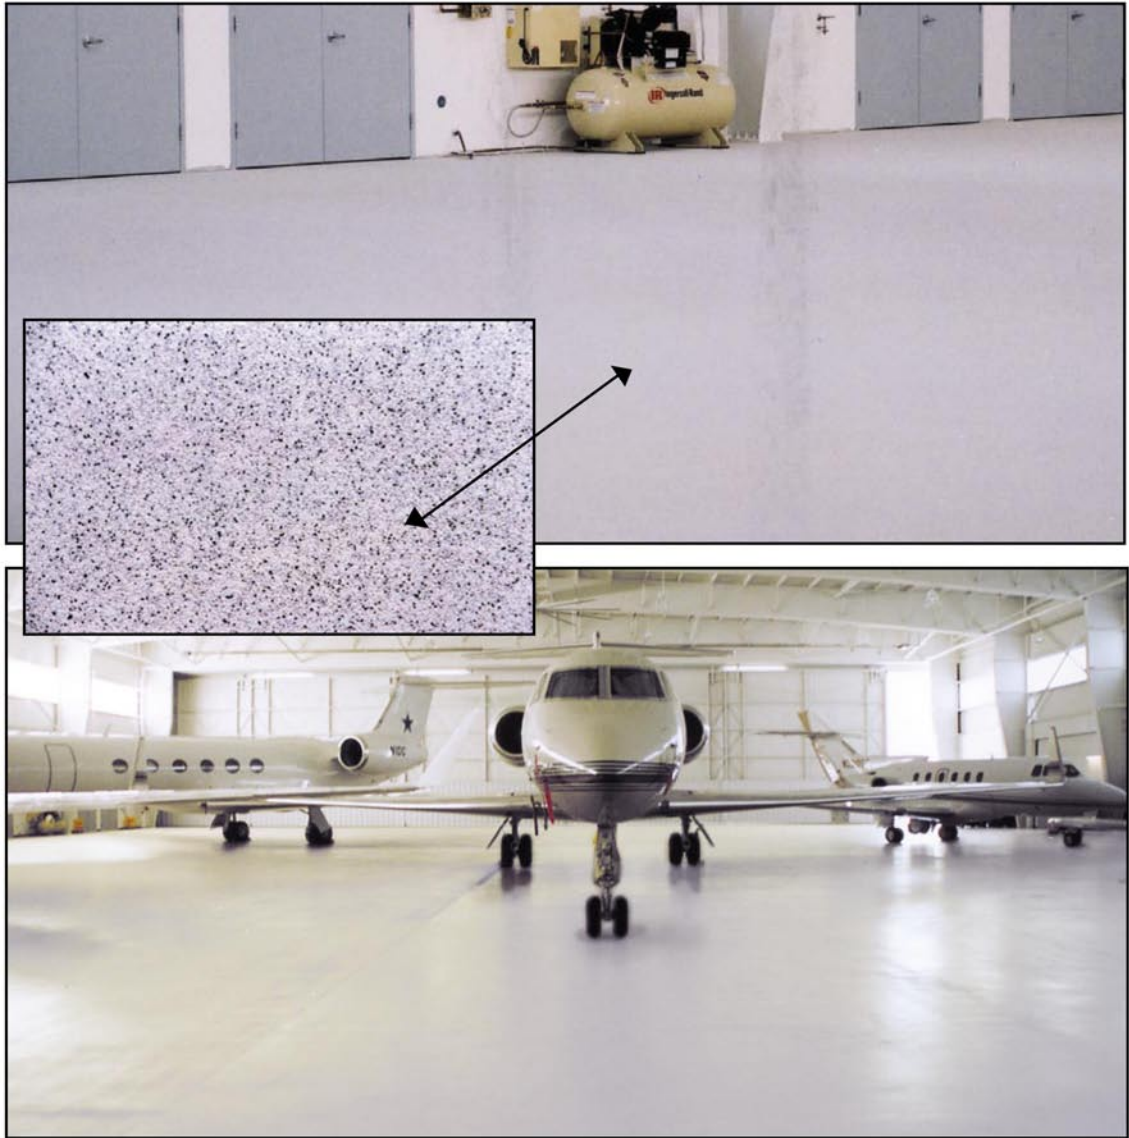
Finished floor
