ROBERT "TONY" HANNAMAN  
 COLORADO SPRINGS AIR PARK  
 905 AVIATION WAY  
 COLORADO SPRINGS, CO 80916

This draft case history documents the hangar floor installation in June 2008.

PRIVATE HANGAR

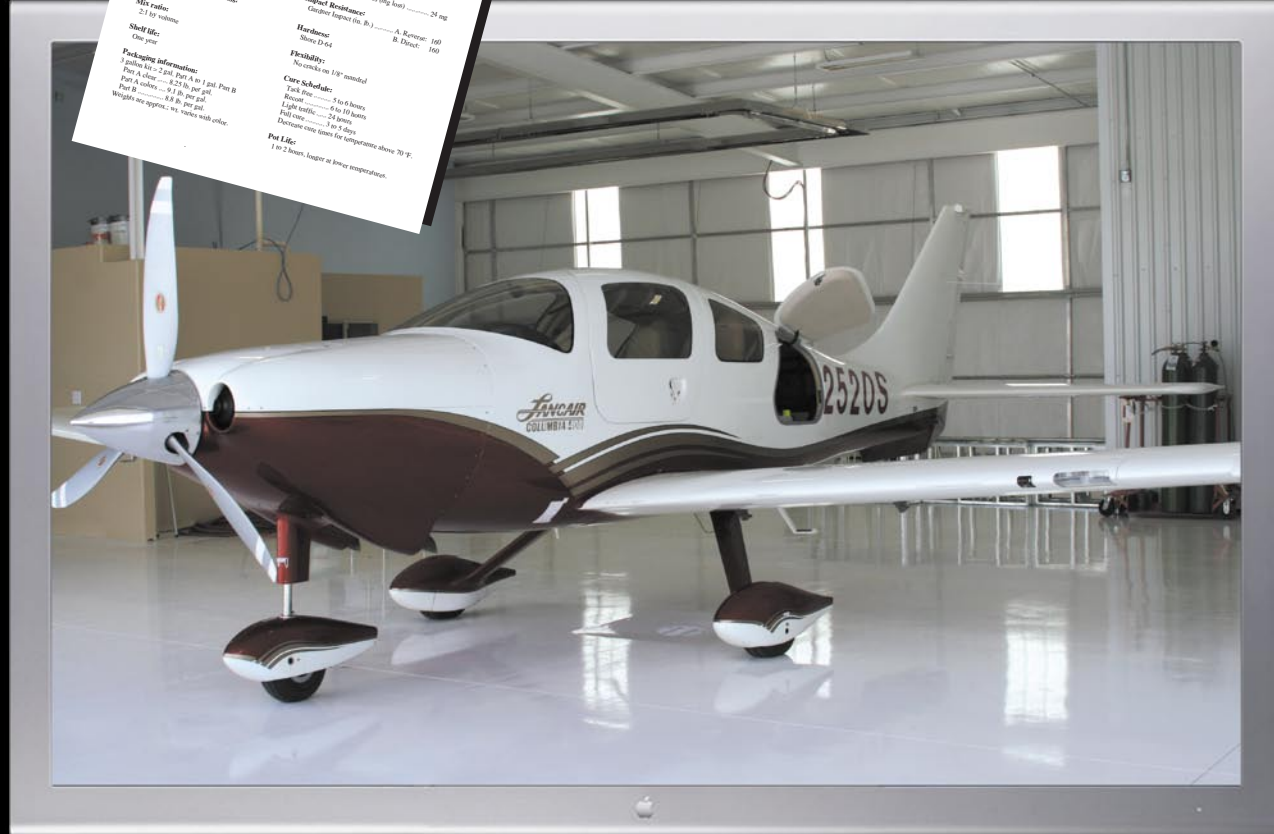
Final topcoat of U31-1201 applied: Aircraft moved in September 2008.

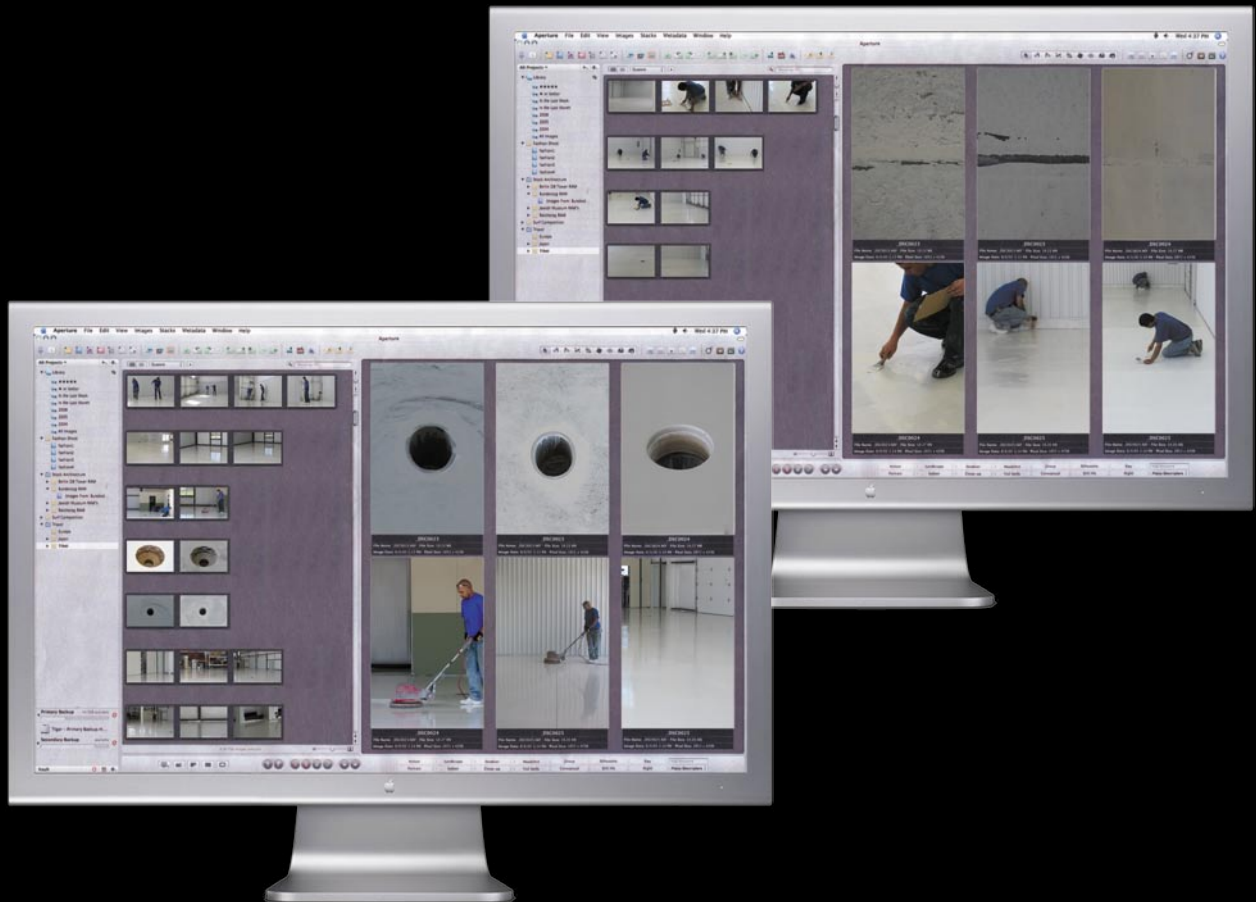
**Did this project pose any unique problems?** Yes, the control joints were caulked prior to our arrival (most of them) with a poly urea caulk that our epoxy/urethane system developed poor adhesion to (the caulk "telescoped" through the epoxy/urethane system showing ridges). All of this caulk was started without our knowledge and prior to our arrival. On arrival, we did comment, "we did not think there would be a problem coating the poly urea caulk."

**Solution:** We had to grind and sand down the poly urea caulk to provide adhesion for the epoxy primer and to create a smooth transition on the floor (because the high gloss polyurethane exaggerates everything). Again, we had to sand and grind down many times exposing the poly urea caulk which "fish-eyed" through the U31-1201 topcoats (all of this is shown in the photographs below). Besides the grinding/sanding of the poly urea caulk, we had to apply extra coats of E31-1202/U31-1201, all at considerable extra expense and time. **The main point**, we are not blaming anyone: we will chalk this up to experience.
