Hangar Floor Case History Report

Frito Lay's new corporate hangar (under construction) / General Contractor: **Constructors & Associates**
Carson Coleman project manager (214) 878-2225

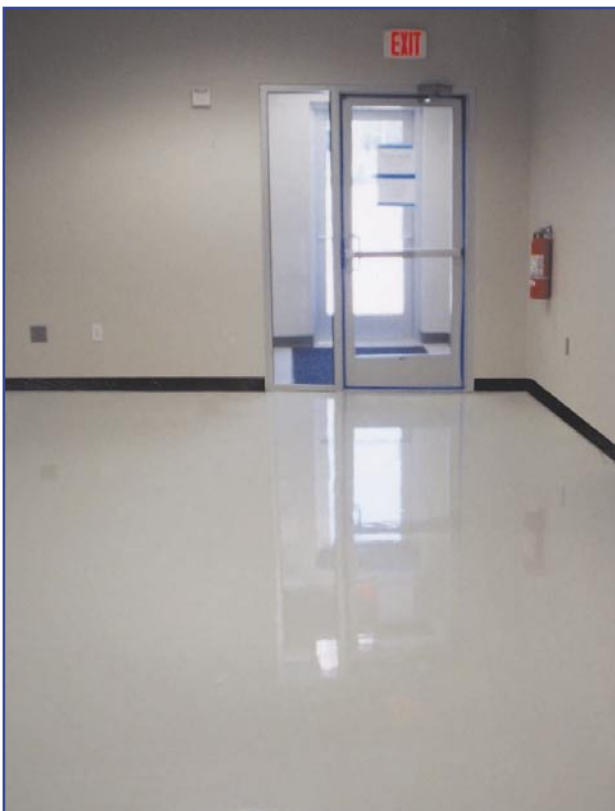
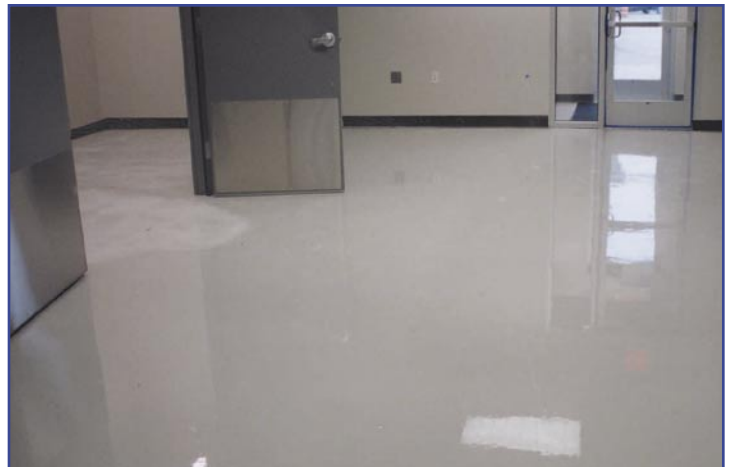
Maintenance shop complete
E31-1202-64
E31-1202, E31-1204
U31-1201

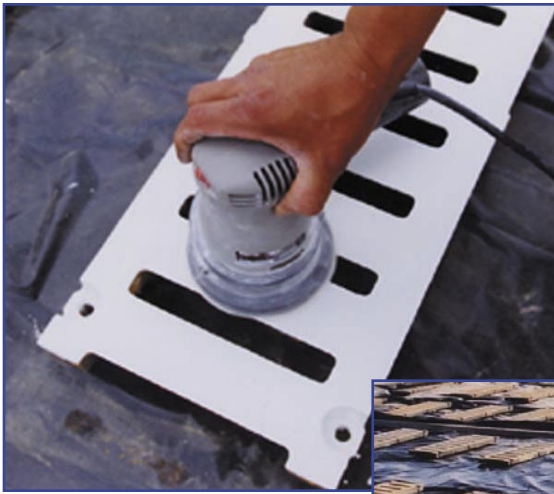
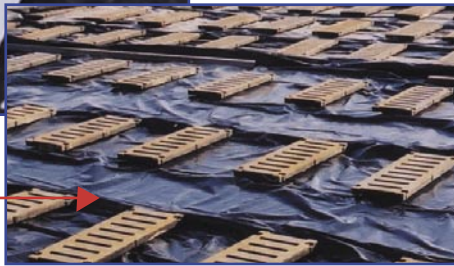
Floor shot blasted, control joints cleaned, backer rod placed and caulking started

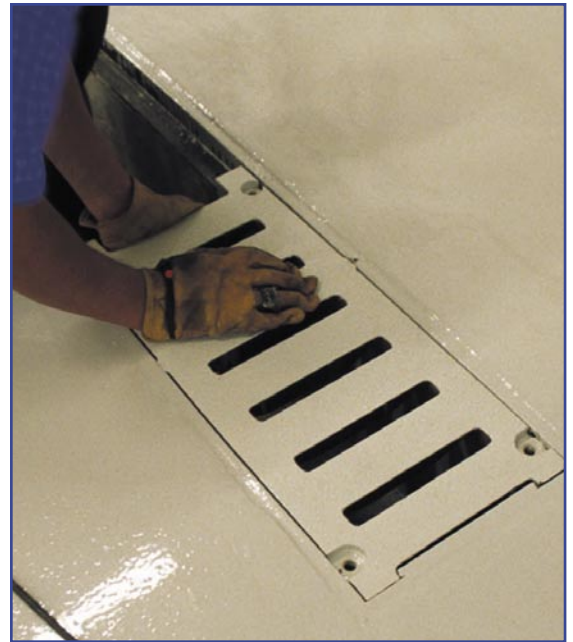
Grates being staged for painting

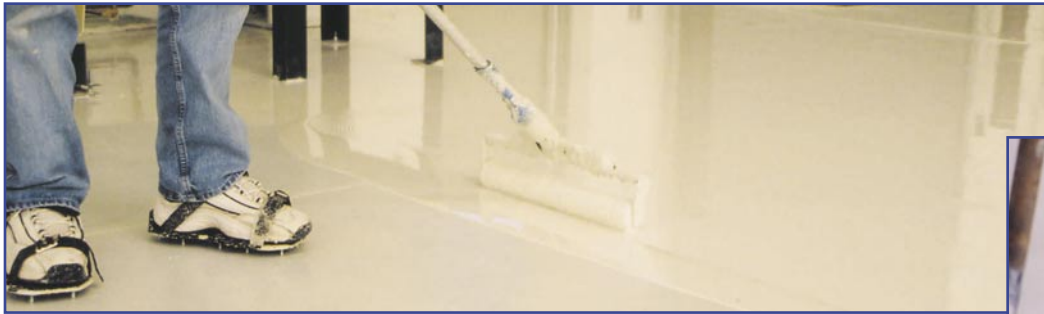
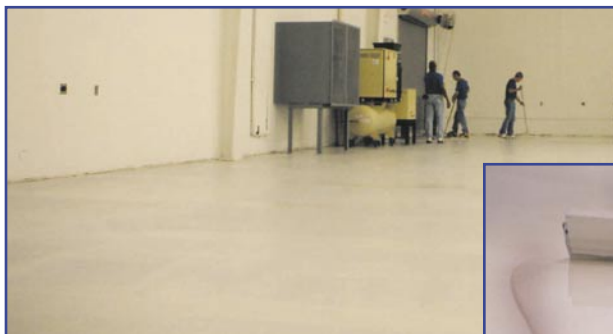
E31-1202 100% solids epoxy being applied using spikes, squeeeges, and then “back-rolled” / floor primed with **E31-1202-64**

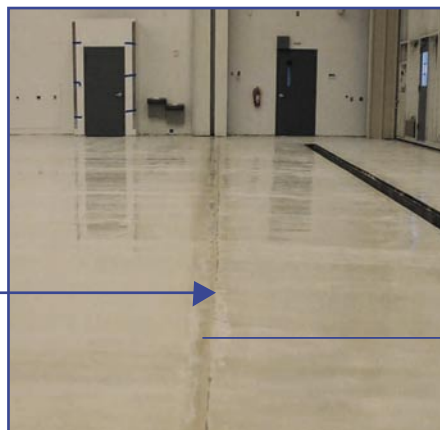
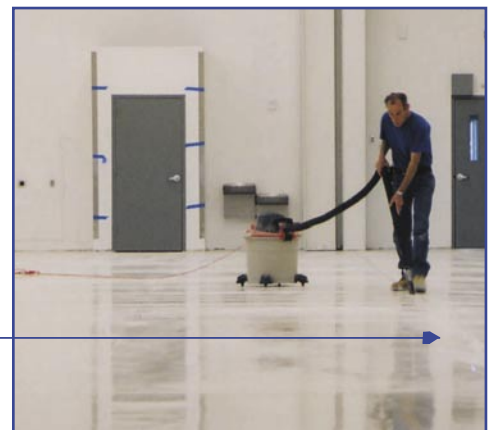
Filling / repairing uneven “cold” joints along door and hangar floor.

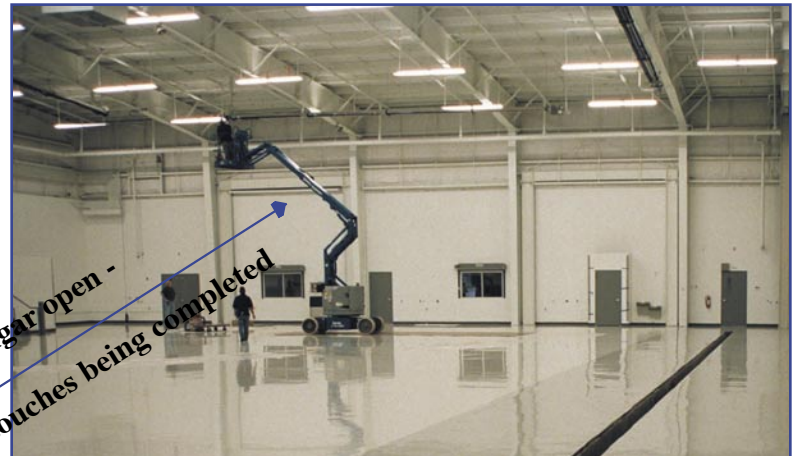
100% solid epoxy overlayment applied (**E31-1202**) and sanding started [preparation before high performance urethane topcoat application (**U31-1201**)]

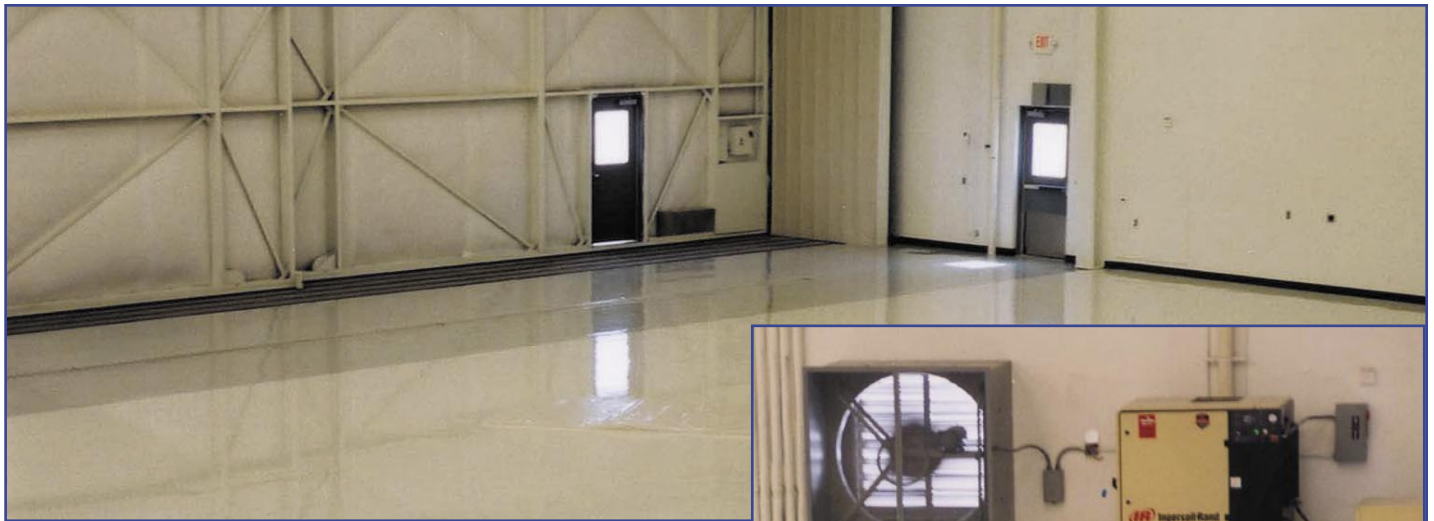
Hangar floor completed

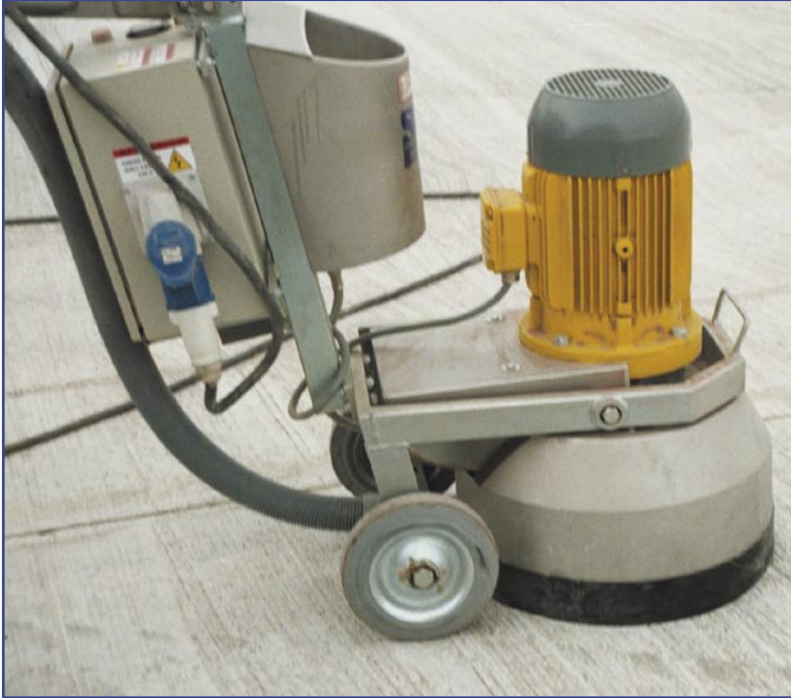
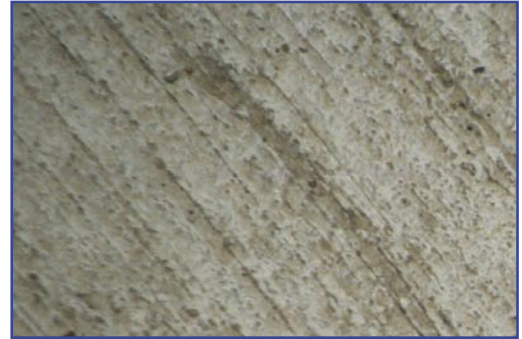
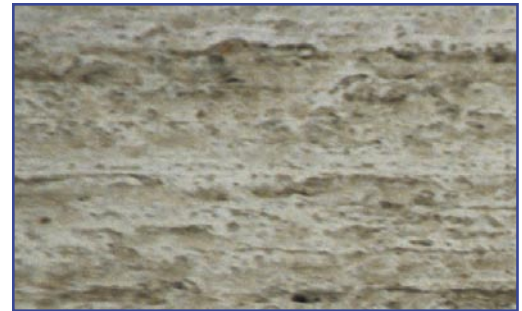
Did this project pose any special / unique problems? **Yes.** The ramp area was very rough and had to be diamond ground (so as not to “tear-up” expensive aircraft tires making tight turns).
