Having a discussion... Hydrostatic Pressure (“Bubbles/Blisters”)

Draft
06/2006

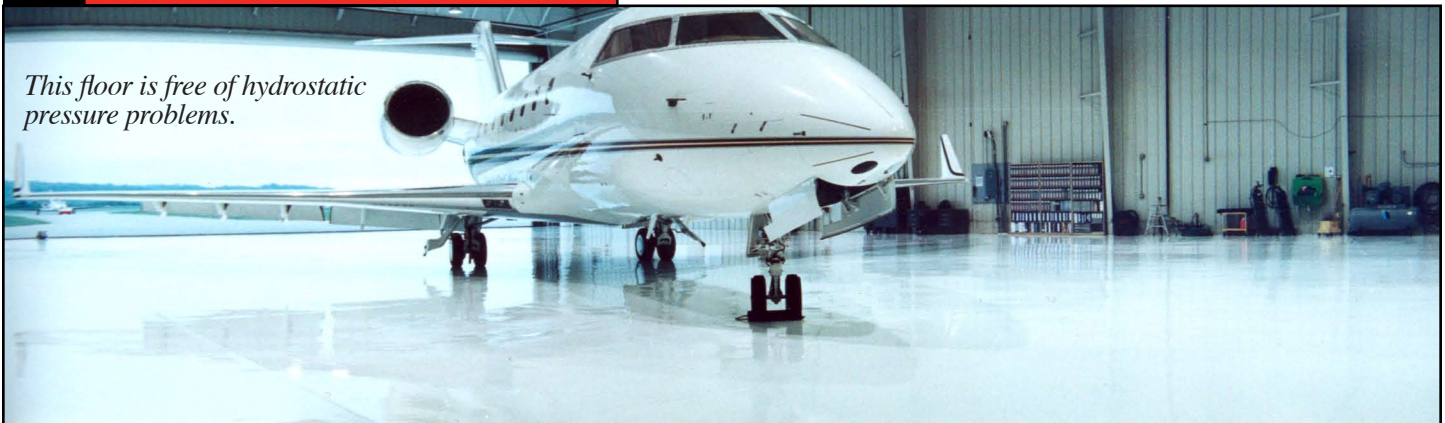
NO "BUBBLES"

This floor is free of hydrostatic pressure problems.

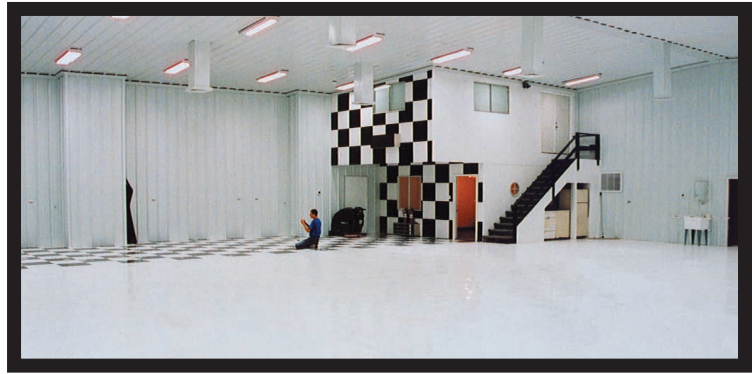
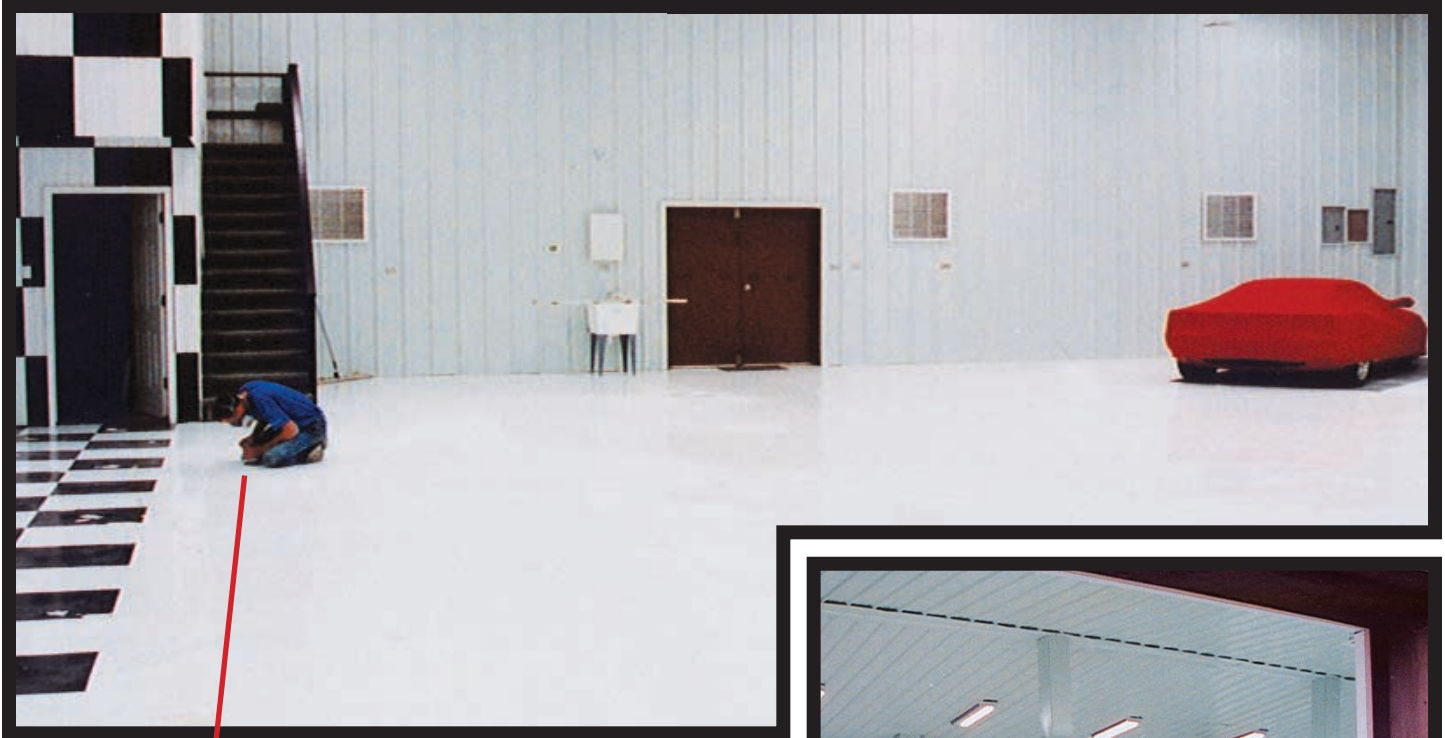
Postscript 12/05

The attached photographs shows a beautiful, hangar. Unfortunately, the floor has hydrostatic pressure problems, but mainly isolated to one, small area.

When a highly cross linked, dense urethane (that cannot breathe) is used, this is sometimes the result. Fortunately, the overall result outweighs the problem areas. There is no solution except removal and repouring of the concrete, or applying a breathable coating system (of course, with a loss of performance properties, e.g. gloss, color retention, chemical/abrasion resistance, etc.).

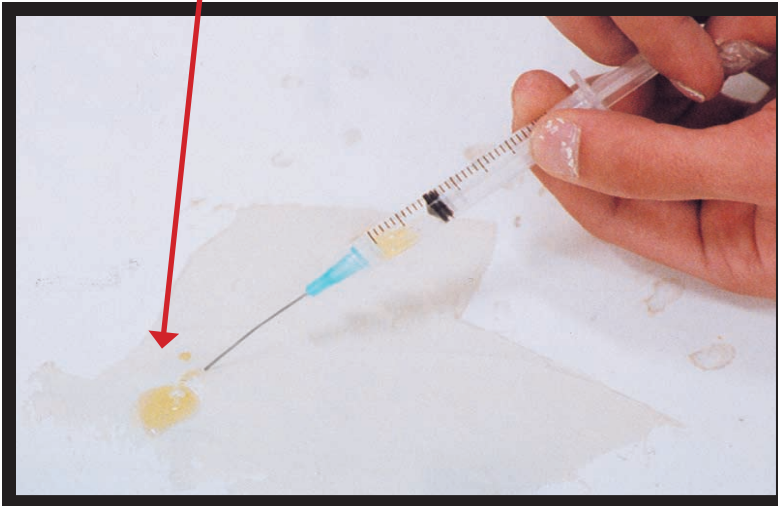
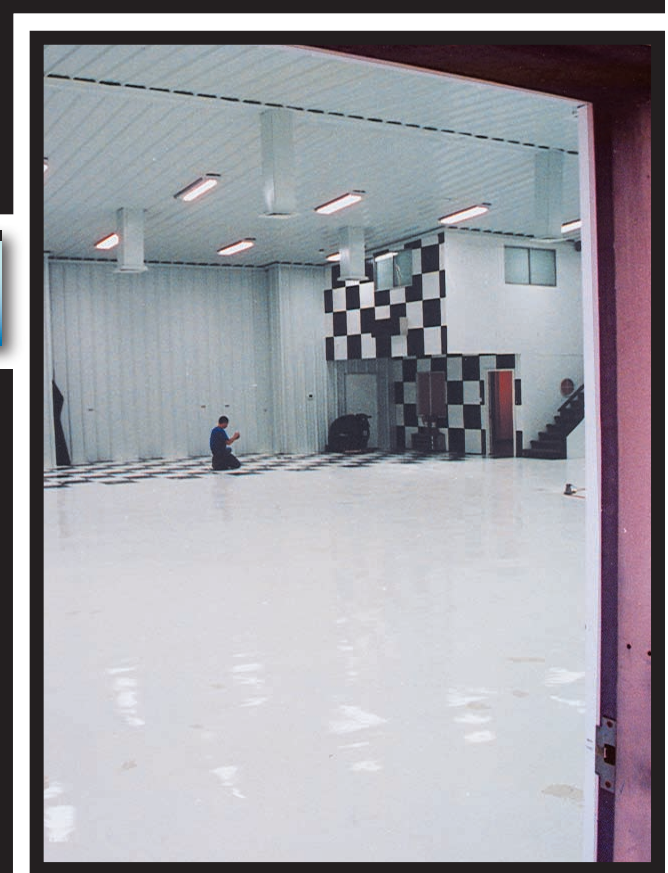
The moisture bubble problem was so severe, we were able to pull almost 2ml out of one bubble. Again, fortunately, this was isolated to one small area of the hangar.

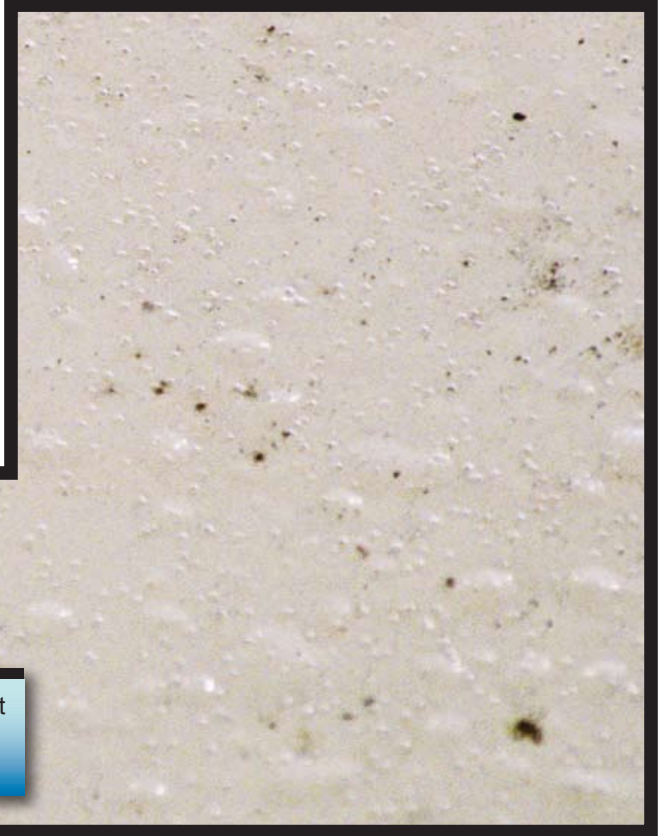
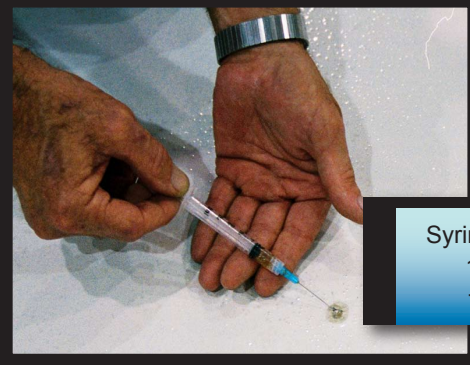
Bubbles/ Water, Oil, Chemical Mixture

Before all of this could be done, "bubbles" developed in one 25' x 25' square. Visual analysis indicated water and an "oily" mixture under the bubbles. Though we knew in advance it was a combination of aviation fluids (oil and other various hydrocarbons, skydrol, avgas, cleaners etc.), the liquid was pulled out by syringes and tested by wet chemical techniques (gas chromatography / mass spectrometry-- GC/MS) for component weight / weight percentage quantitative analysis. The analysis showed greater than 97% by volume H₂O with all of the other above in trace amounts.

Syringe collecting almost 1.5ml of "mixture" from one bubble.

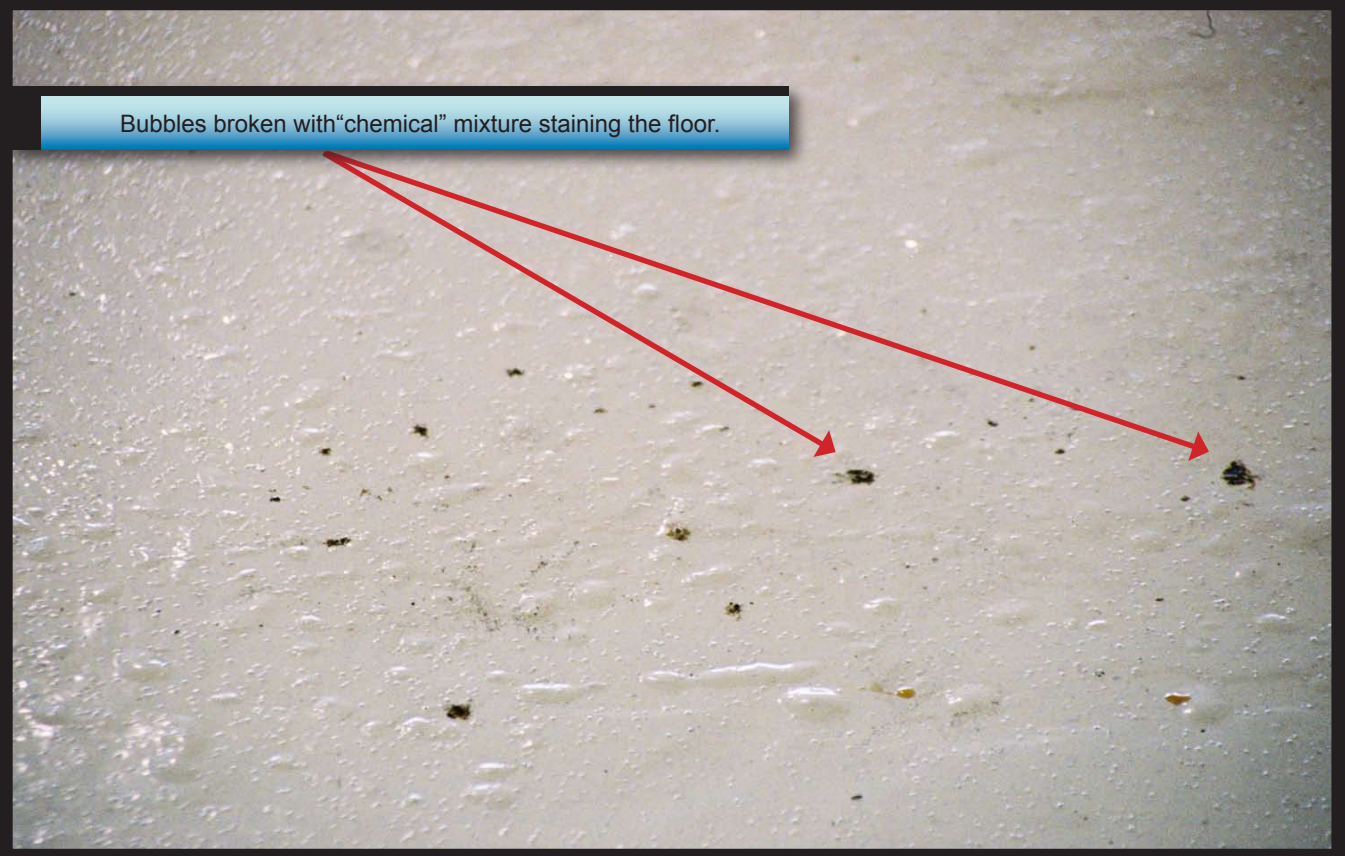
Bubbles broken with "chemical" mixture staining the floor.

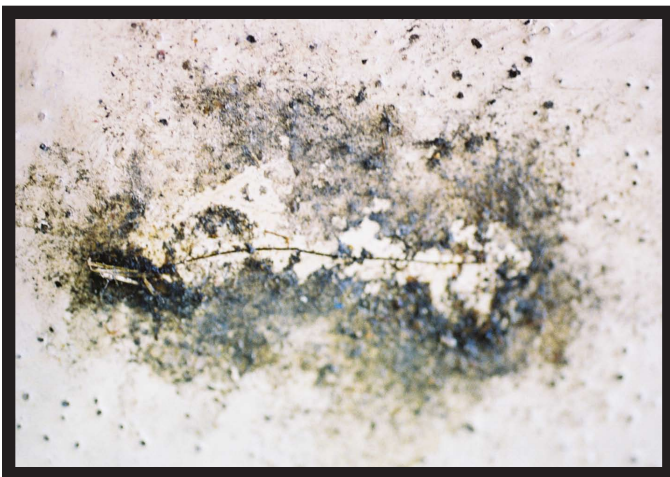
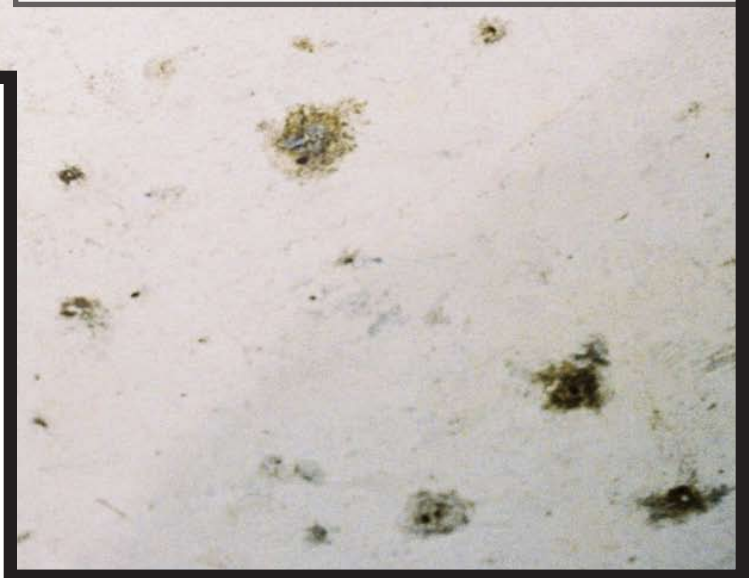
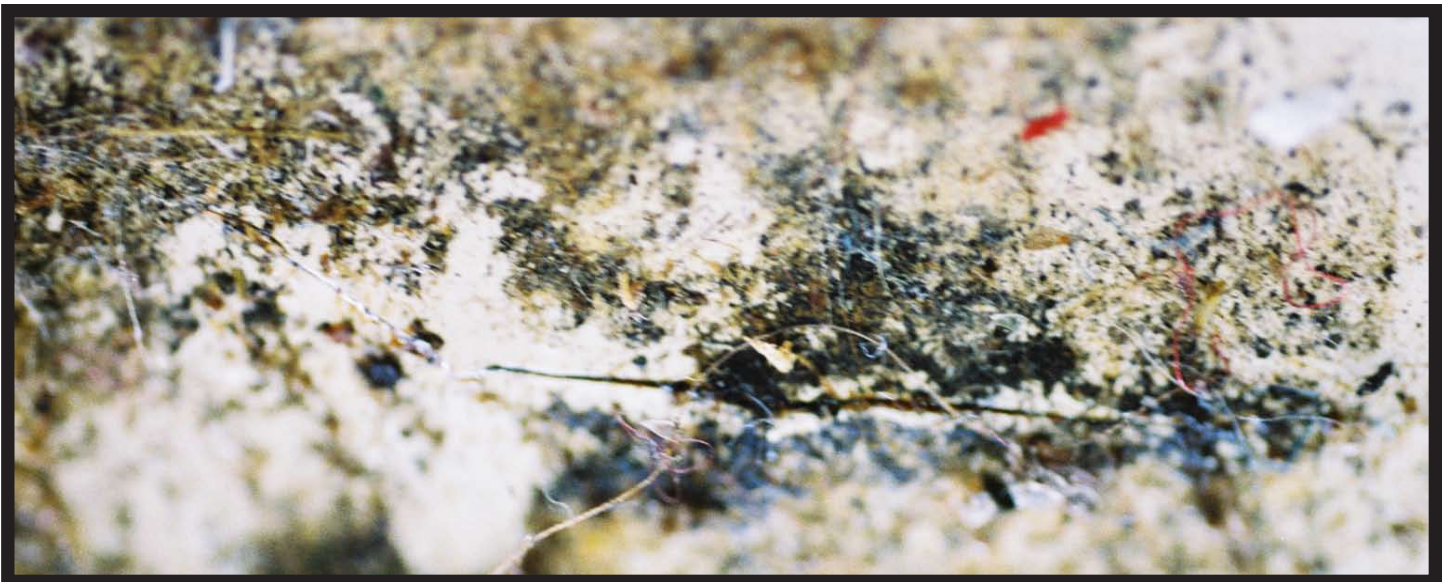
Postscript 8/05 and 6/06 (cont.)

For this same hangar, the attached photographs were taken 6/06 [almost ten (10) months later] and show the hydrocarbon mixture forced up by hydrostatic pressure, cracking the surface with the "oily mixture" being emitted. This "eruption" is easily cleaned off with a soapy solution, a clean solvent (i.e. acetone), or other means, leaving the cracked surface. No concrete is exposed.

The hangar, built in the 50's, was exposed to piston/turbine "leakage" for many, many years before the floor was coated. There is no means to extract the contamination since it occurred over such a long period of time and is so deep (short of jack hammering out the concrete and repouring). This area has been removed to bare concrete and shot blasted/diamond ground twice, but again, the contamination is so deep and plentiful, and with no means for extraction, the "bubbles" reappear each time this area is coated (as soon as the floor is cooled and then heated up, expanding the liquids below).
