Bob Schjerven

Longboat, LLC

PERSONAL HANGAR BOB SCHJERVEN

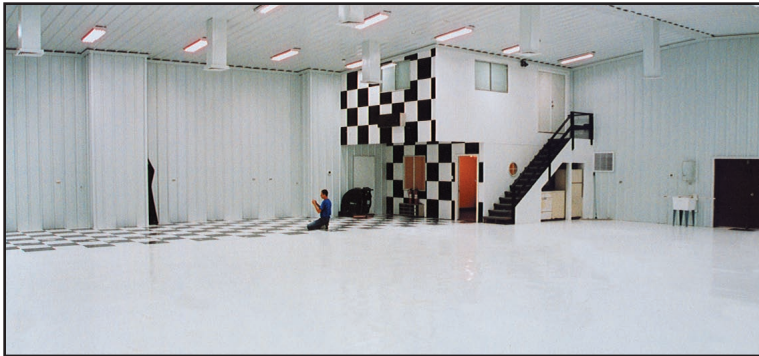
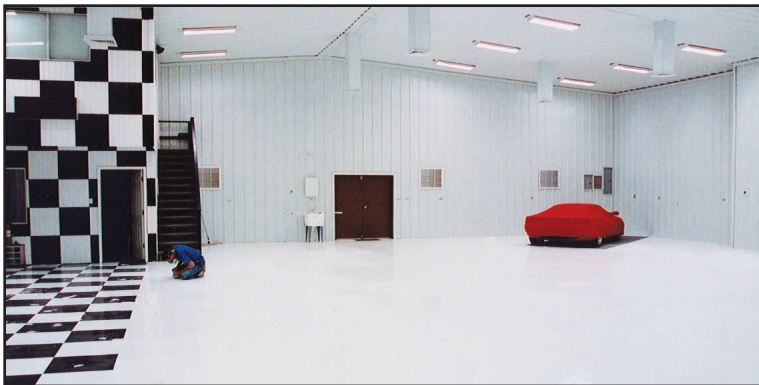
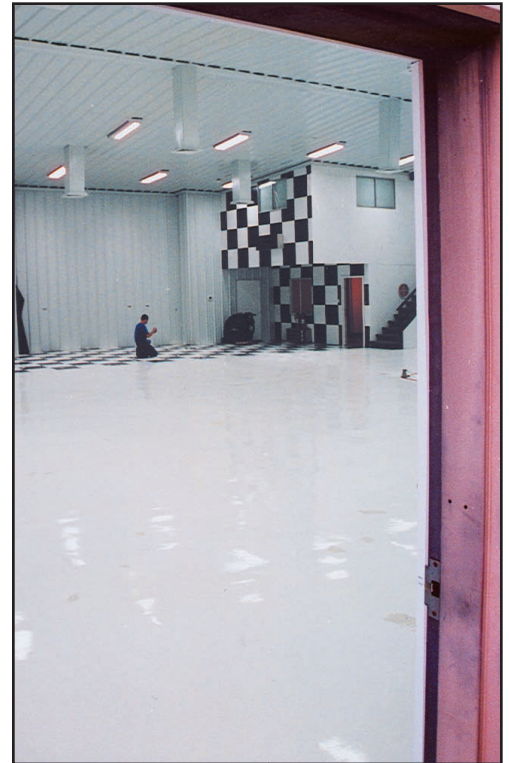
The following photographs show the beautiful, personal hanger, of **Bob Schjerven**. Unfortunately, the floor has hydrostatic pressure problems, isolated to the checker board pattern, and mostly in the black squares. Tests are planned to determine the source of the water and why it is only one quadrant of the hangar floor (recoating of the entire floor may be a possibility).

The moisture “bubble” problem was so severe, we were able to pull almost 2ml out of one bubble.
