CASE HISTORY REPORT SKYSERVICE FBO/AVITAT, TORONTO, CANADA

DATE CONTRACT COMPLETED:
NOVEMBER, 1993

WHAT?: Installation of REDFORD Corporation's high performance epoxy-urethane coating system (U31-1201) to 35,892 square feet of concrete hangar floor include painting all exposed structural steel members (on four walls and ceiling) with two coats of DTM Ceiling and Wall Coating (to match preexisting siding color).

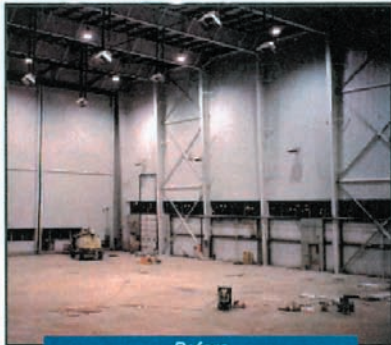
Before

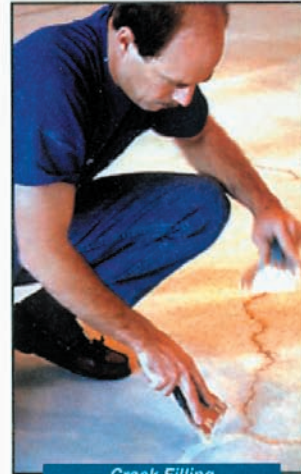
Crack Filling

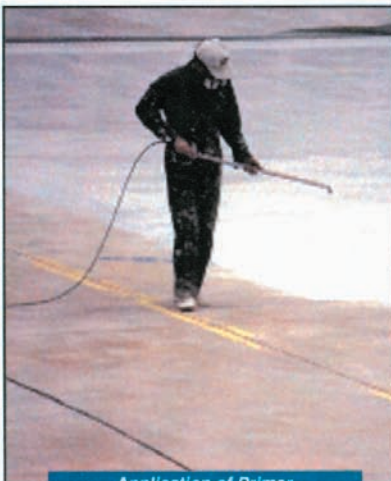
Application of Primer

HOW?: Did this project pose any unique problems?
Yes. The concrete floor had an impregnated iron particle finish. Careful attention to the primer and etching process was considered before a correct selection of primer (E31-1202-64).
