Addison, Texas, July 1, 2008 - MSF Partners, Inc. has begun construction of an executive hangar community at Addison Airport today. This complex is being developed as a condominium association and named the Executive Hangars of Addison Association. Twenty three units in three sizes ranging up to over 8,000 square feet are being built. Richard French, MSF Partner's President, commented on the executive hangars, "We are excited to see dirt moving on what will be the most beautiful hangar community at the airport. Our buyers and their guests will enjoy amenities far beyond those to be found at the airport today. The high-end exterior and interior finish will set these units apart from any to be seen there today". Completion is planned for May 2009. MSF Partners, Inc. is located in Plano, Texas a northern suburb of Dallas. For further information, contact MSF Partners at 6900 N. Dallas Parkway, Suite 730, Plano, Texas 75024; call (972) 403.0909; or log on to www.msfpartners.com. --- MSF Partners ---

MSF Partners/IAM Construction contracted with REDFORD Corporation to paint the structural steel and install a high performance epoxy/urethane coating system [twenty three (23) hangars]. Th

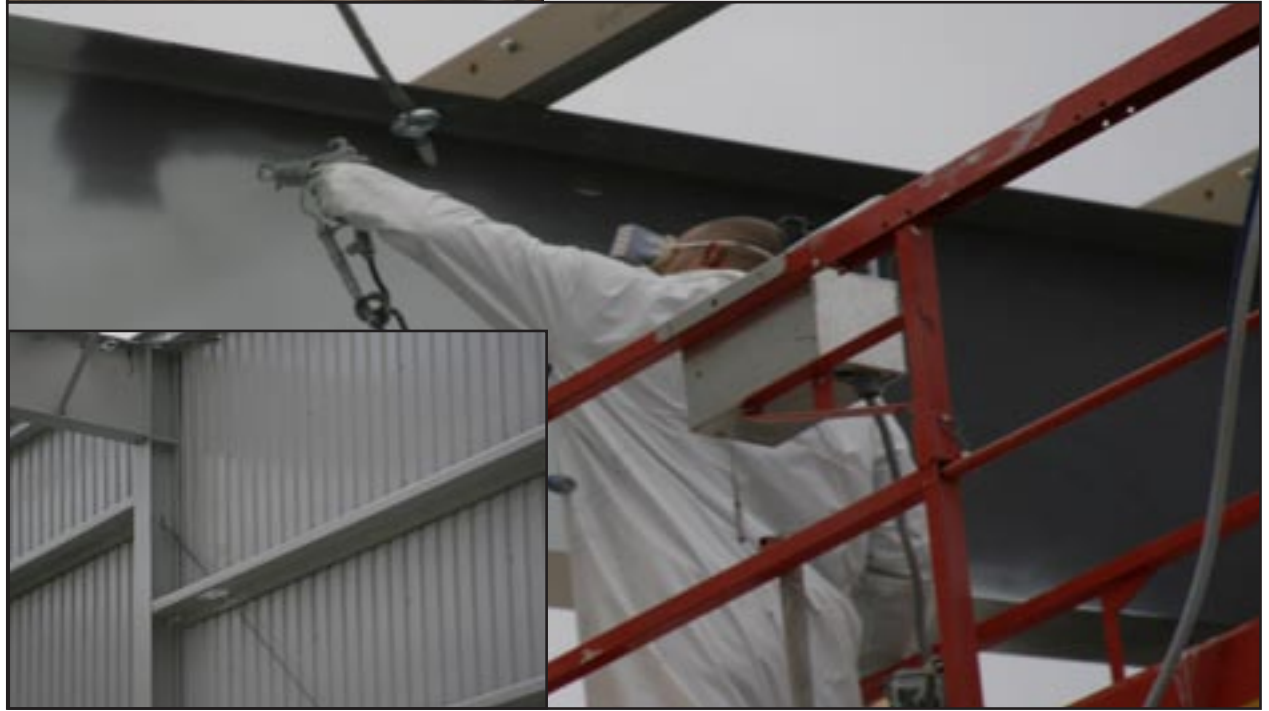
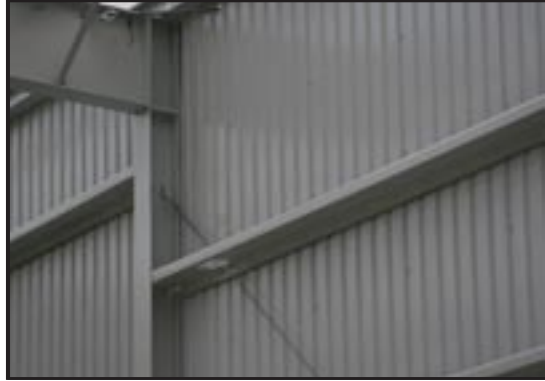
These photographs show a DTM acrylic being applied to the structural steel (March 2009).

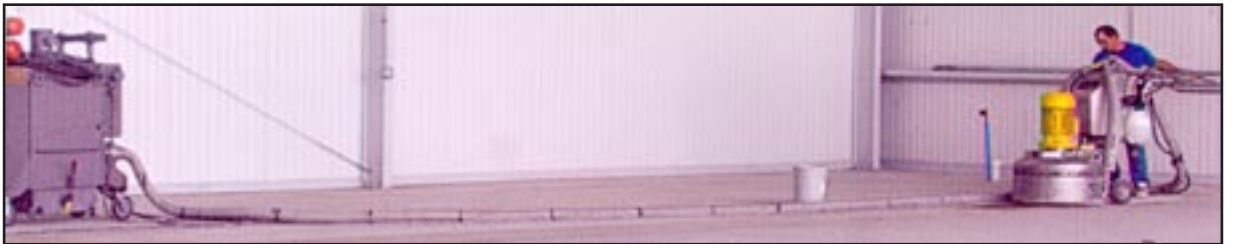
The start of the shot blasting / diamond grinding of the 23 hangars.
