Christian Brothers Automotive

4121 State Highway 121
Carrollton, Texas 75006

General Contractor:
Halstead Contractors, LLC
5455 Troy Highway
Montgomery, Alabama 36116

CHRISTIAN BROTHERS AUTOMOTIVE CARROLLTON, TEXAS Automotive Shop Floor

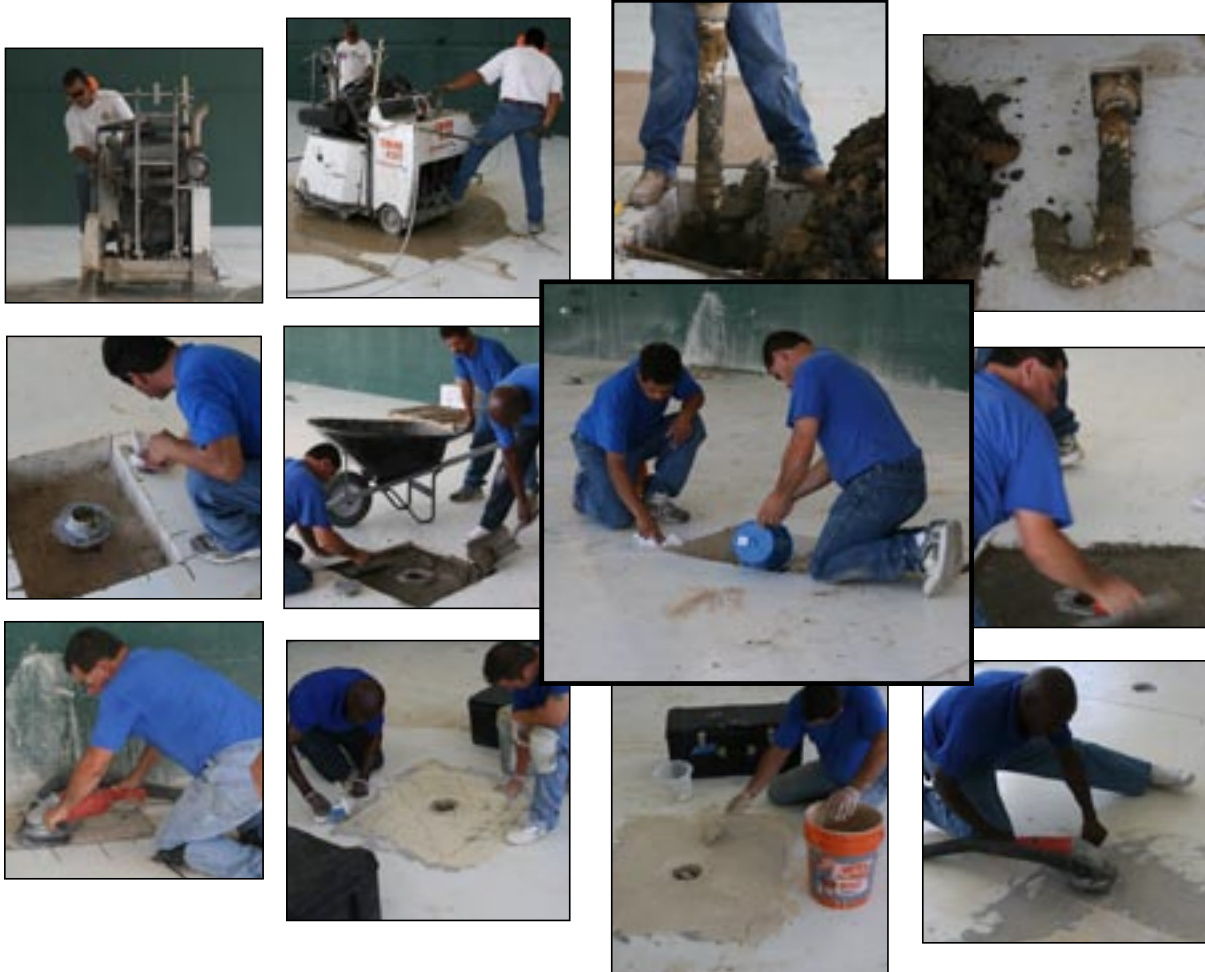
Were there any problems with this project? YES! In the course of filling/repairing the spalled, broken out drains, we accidentally poured epoxy down in the drains (not realizing there were vent holes in the drains themselves). Again, in the course of filling the broken out areas around the drains and not knowing of the vent holes beneath the surface, we accidentally poured epoxy and subsequently clogged the drains. We had no alternative but to saw cut out and replace the drain elbows.

These photographs display the cutting, breaking-out process, and the placing of new drains.
